SHORE EROSION
OF
HOOVER RESERVOIR

Ned A. Mosher
Environmental Geology 594
December 15, 1971

Geol. 594

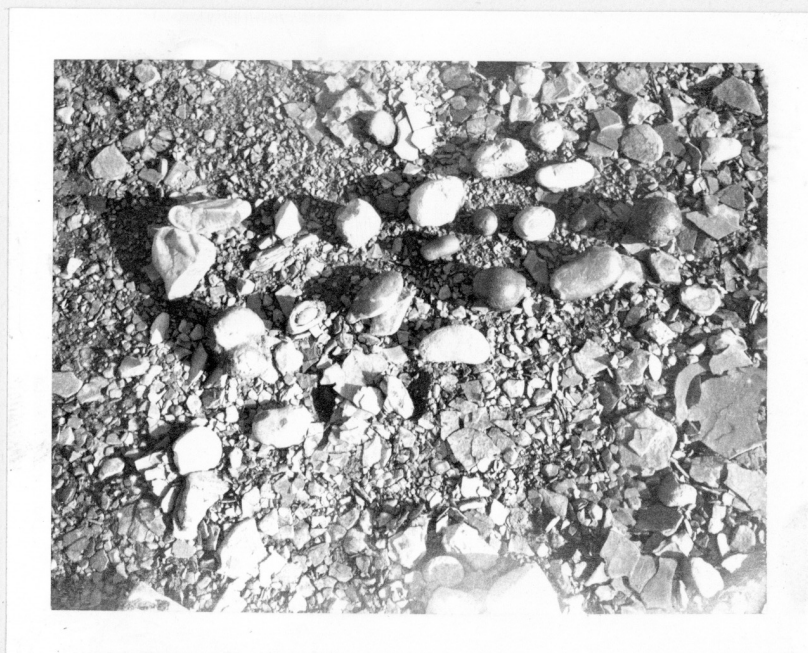
Figure 2. Iron pyrite concretions
of Ohio shale

The Ohio shale which forms the channel of Big Walnut Creek which outcrops at the lower level of the east bank. "It is a brownish or bluish black shale in fresh exposures, but weathered surfaces have a distinctly blue color."¹ This shale is quite firm and somewhat massive when first exposed but breaks up into small fragments and into a stiff clay over a long period of weathering. The upper part of the formation contains numerous small flat concretions of iron pyrites which is quite obvious in the vicinity of Central College and just above the spillway. (See figure 2)

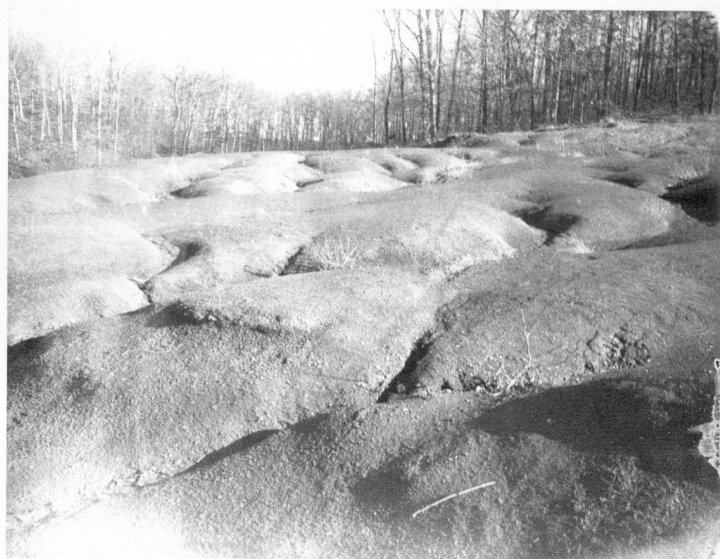
Figure 3. "Bad Lands and Red Hills"
Bedford shale of Central College

The Bedford shale formation forms most of the east shore of the present level of Hoover Reservoir. This is a very soft, easily eroded formation, full of hematite which gives it the characteristically red color especially when weathered. The hills east of the location of Central College were once well-known for their exposures of this red shale which gave its nickname locally "Red Hills."² Because of striking likeness of the topography of this area to the "Bad Lands"² of the West it has also assumed that name. (See figure 3 & 4)

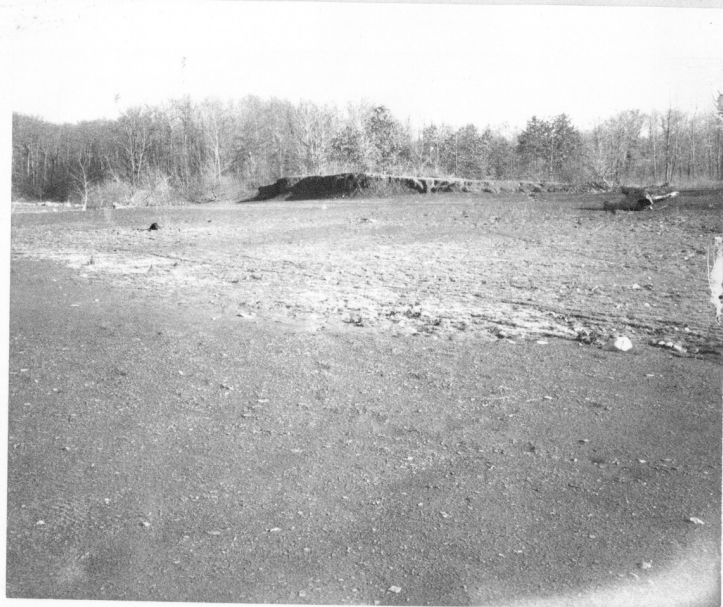
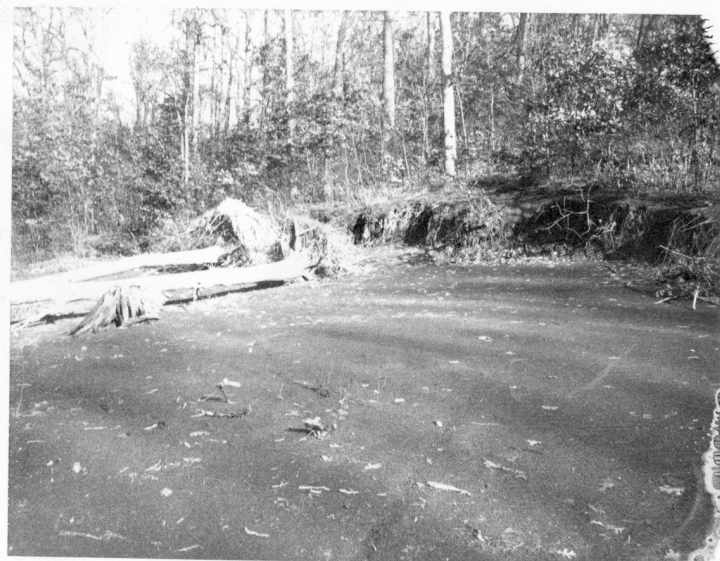
Figure 5 & 6. Terraced erosion east shore Hoover Reservoir

The other reasons for the shore erosion mentioned earlier which causes considerable damage is the change in the level of water. This of course causes extensive cutting at many levels. At the present time the level is 16 feet below the spillway level and many terraced erosional levels can be readily observed. (See figure 5 & 6) No plant cover can be established and therefore all the mechanical and chemical agents continue to destroy the shore. This practice leads to the increased siltation of the reservoir which is already at a peak because of the watershed being one of high erosion rate.

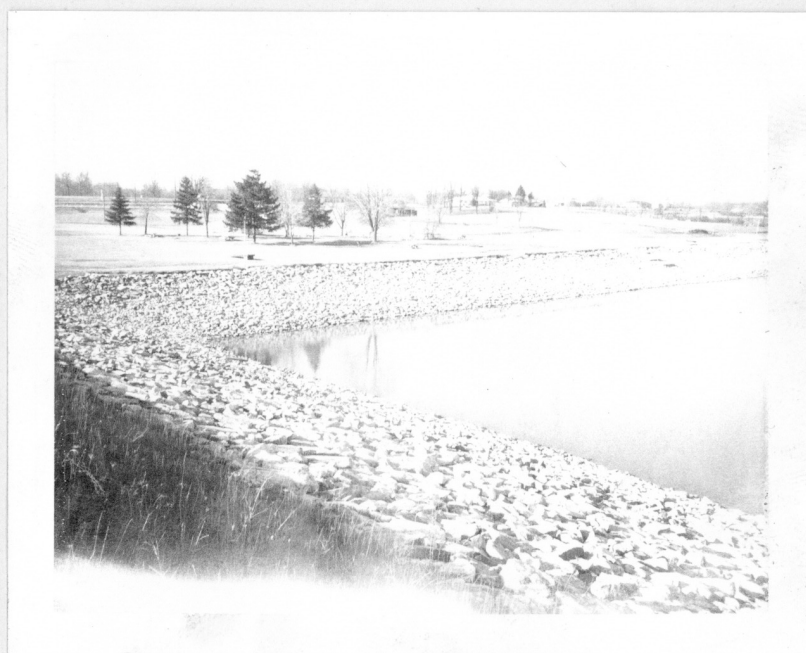
Figure 7. "Rip-Rap" at spillway
Hoover Reservoir

The most desirable method of control would be to "rip rap" the entire shore line. (See figure 7) However, this would cost upwards to \$30 million, twice the cost of the original dam and reservoir. The second alternative and the one which the city seems to be taking is to purchase the additional 284 acres needed for right away and let it erode and "rip-rap" the most critical areas at a cost of \$100 to \$125 per lineal foot. Other less evident but never the less important processes can help reduce the problem and should be put into practice at once. This includes reforestation of the east slopes, controlling the level of the reservoir with less variations in exposures especially in the winter and more long range planning in the initial stages of building and land acquisition for a reservoir. Another alternative, dredging, would not be economically feasible at this time since a new reservoir could be built at less cost. Many similar situations could be avoided in the new Alum Creek Reservoir to the northwest of the location, and preserve what land might otherwise be lost in the future.
